Technical Service Bulletin - TB019

Date: June 13, 2013

Product: ATC32U01_ Communicating Thermostats.

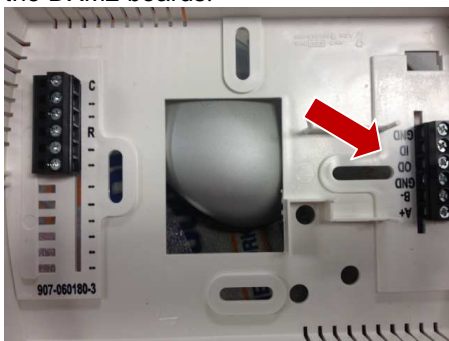
Issue: Incorrect labeling of connection terminal at the thermostat base. The screen print labeling communication connection terminals is placed upside down. If communication harness from the DXM2 board is connected to the terminals as marked (A+ B-) shown below in the picture labeled as "incorrect labeling" will result in communication Error. Thermostats will not communicate with the DXM2 boards.

Solution: ClimateMaster has developed a correct labeling sticker part number 95B0040N01 which can be applied over the screen print to indicate correct connections as shown in the picture labeled "Correct labeling". Stickers can be ordered through normal warranty parts ordering process. Connect communication harness/wires according to the correct labeling to correct the communication error.
