## TECHNICAL SERVICE BULLETIN

**Scope:** Refrigerant leaks at compressor discharge tube connection

**Product:** GS015 & 018

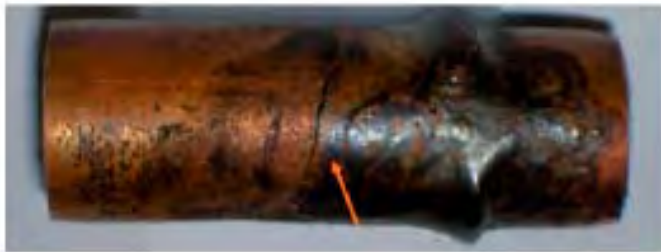
ClimateMaster has had reports on the subject models, which have experienced a refrigerant leak on the compressor discharge tube between the compressor and the reversing valve. The most common location has been on the discharge line close to or at the compressor stub. Units built after September 12, 2005 are not effected.

These fractures have been caused by a harmonic frequency vibration of the tubing assembly within the unit. This harmonic frequency can be caused by many factors and can change as one or more of the factors change, and may not be present in all units. Some causes include factory compressor mounting bolts not loosened, shipping clips not removed, unit operating voltage - effecting compressor motor speed, water flow rate and entering water temperature - effecting refrigerant pressures.

Close up of tube fracture →

- 1) Repair leak by removing the effected portion of tube and re-braze to compressor.
- 2) Check to ensure the compressor mounting has been loosened and is floating freely.
- 3) Determine if there is any excessive vibration and/or movement of the copper tubing.
- 4) If there is excessive vibration, add a line weight in the designated location. (see instruction below) For questions or clarification regarding line weights contact ClimateMaster Technical Service.

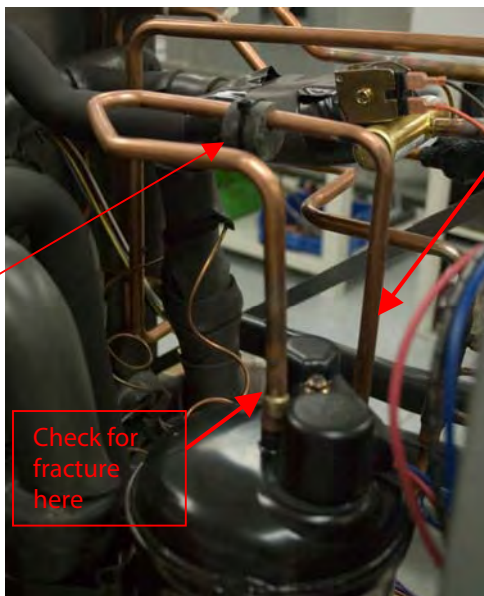
3/8" tube line weight  
Part # 69881300

Check for vibration here

Check for fracture here

If excessive vibration is confirmed or suspected the harmonic frequency of the tubing can be altered. The typical method is to add mass and therefore weight to one or more refrigerant tube(s). ClimateMaster has found the addition of line weight to the offending tube to be an effective repair. The photo illustrates the recommended line weight and installation location. To install the line weights, open the line weight at the pre cut slit and position so the hole fits snugly around the discharge line in the recommended location. Multiple weights can be used on vertical and/or horizontal tubing to dampen the line movement. Secure the weights with a six or eight inch cable tie to insure the weights do not vibrate loose which can lead to noise and/or the weight moving or becoming detached.

Locate line weight as shown secure with cable tie
