Technical Service Bulletin

TBJ002D

Date: October 20, 2006

Product: ATP32U01, ATP32U02 & ATA32U01 thermostats in conjunction with units using auxiliary electric heat.

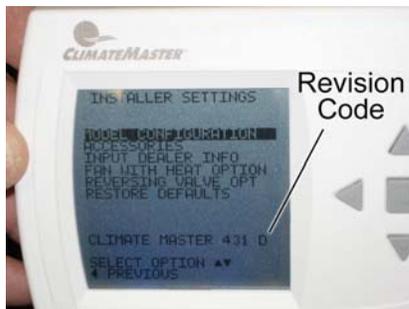
Effected Range: Uninstalled thermostats can be checked by the date code and/or part number. The thermostat’s box label (shown lower right) lists the part number and date code (first 2 digits indicate week, last 2 digits indicate year). Return any thermostat with date code of **3506** or before without the part number highlighted in yellow. Correctly programmed thermostats have either a date code of **3606** or later or any date code with the part number highlighted in yellow. Example would be of lower right picture; even though date code is before 3506, the part number is highlighted in yellow indicating this thermostat has the correct program. Installed thermostats should be checked by the revision codes (shown in lower left picture). Compare revision codes to the chart listed below.

Solution: Affected thermostats must be replaced and returned to ClimateMaster. Replacement thermostats must be ordered through the Business Center, credit will be issued upon receipt of returned thermostats to ClimateMaster. Request a Return Authorization in the comment section of the order.
