TB-G006

## TECHNICAL SERVICE BULLETIN

**Scope:** AGM12A Auxiliary Electric Heater

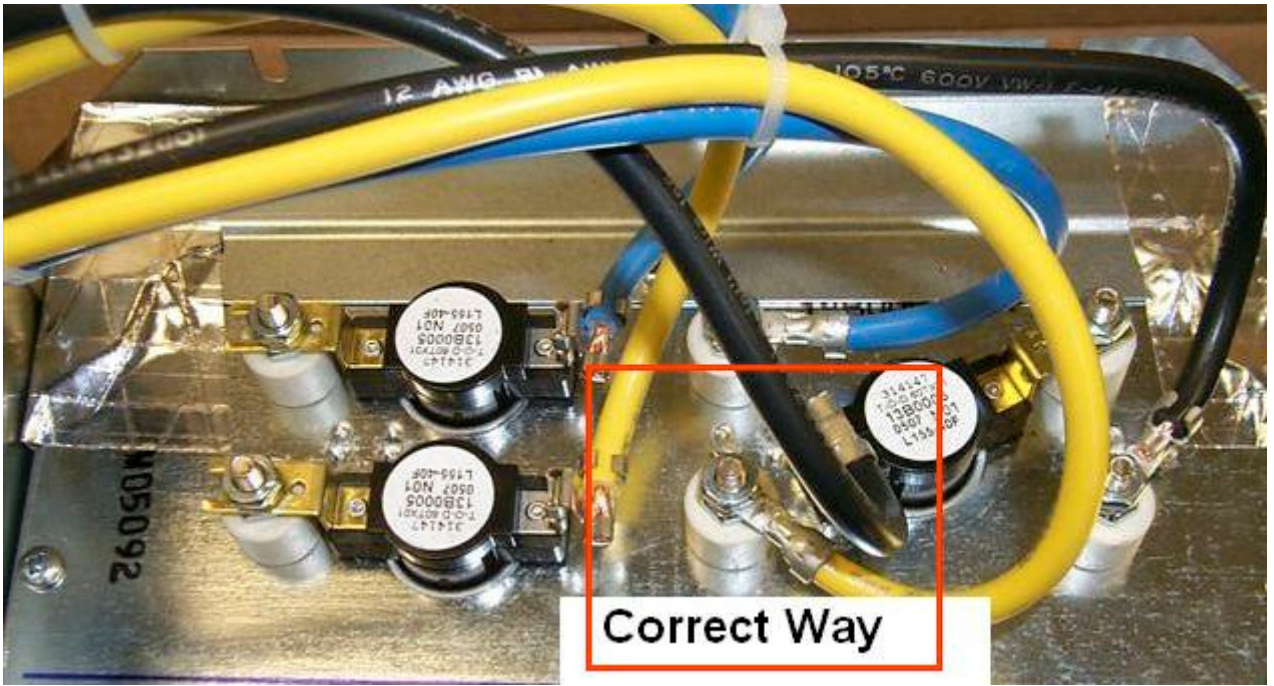
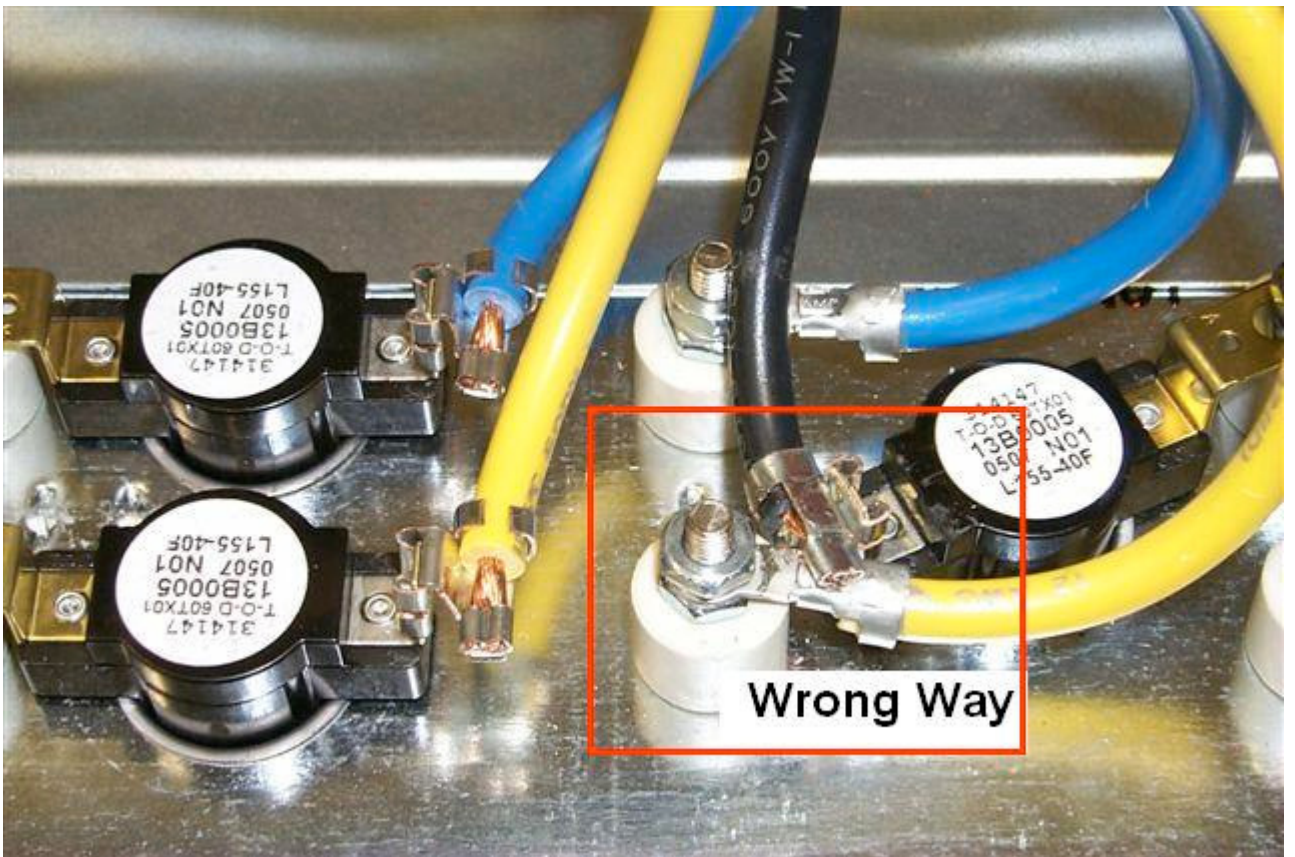
ClimateMaster has discovered a potential assembly error with the some of the model AGM12A Auxiliary Electric Heaters. The result can be a short circuit between two wiring terminals within the heater control box. In the event power is applied to a heater with the problem damage to the heater and/or wiring may result.

ClimateMaster has inspected and corrected all affected heaters in our inventory. We are recommending heaters in Distributor should be inspected. Photos of the correct and incorrect terminal connections are attached for clarification.

Heaters that are found to have the terminals in an incorrect position can be easily repaired. To repair the heater remove the wire connected to the heater overload with the reverse flag terminal (black wire in photos). Rotate the terminal 180 degrees and reconnect to the overload. The reverse flag terminal should project over the overload and away from the screw terminal. Also check the position of the wire attached to the screw terminal, (yellow wire in photos). The ring terminal on the wire must be positioned so the wire points away from the overload and the reverse flag connection.

Heaters that have been installed can be repaired with the above method unless the heater has been energized and damage has occurred. In the event damage has occurred ClimateMaster will provide a replacement heater at no cost.
