## Technical Service Bulletin

TBJ012

**Product:** TTV/D, TSV/D and all other vertical up-flow and down-flow ClimateMaster units equipped with stainless steel drain pan option

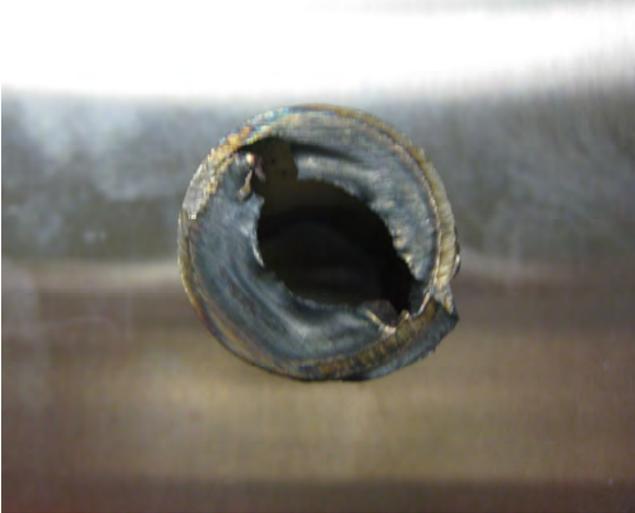
ClimateMaster has become aware that, on some vertical up-flow and down-flow units equipped with stainless steel drain pans, the nipple of the drain pan may have slag partially covering the hole from the cutting process (see example picture below). This slag may restrict the condensate from adequately draining. This will become apparent if lint, sludge and other debris becomes lodged around this slag causing blockage of condensate flow.

Note: picture is a sample and not typical, it has been purposely exaggerated to show worst case scenario.

As all ClimateMaster units are equipped with condensate overflow protection, the condensate will not overflow and cause damage. Immediate inspection of all units is not warranted or required. This technical bulletin is meant to assist servicing contractors that may be experiencing units faulting on code 6 (condensate overflow protection) and upon inspection, the condensate tubing, both internal and external of the unit, are found to be free of restriction and are of proper size and slope away from the unit towards the drain.

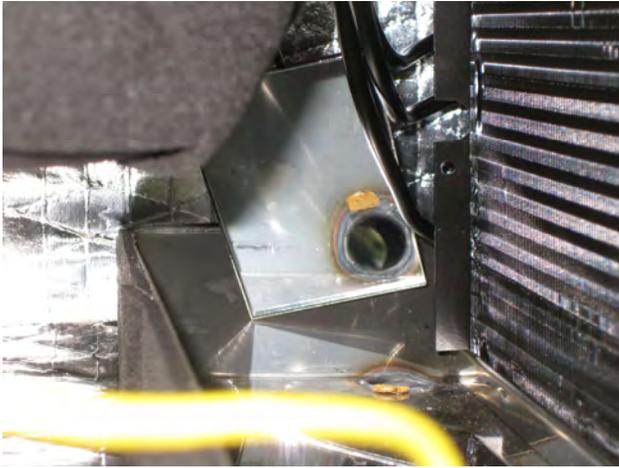
To inspect units, disconnect electrical supply voltage to the unit in accordance with lock out/tag out procedures. Remove the access panel to the air coil section. Using an inspection mirror, check to see if the drain nipple is obstructed.

If no obstruction is seen, the code 6 faults being experienced are not related to this Technical Bulletin. Continue diagnostics paying special attention to proper slope of the condensate drainage and verify other sections of the condensate drainage are free and clear of debris.
